REGIONAL DISTRICT OF OKANAGAN-SIMILKAMEEN
Protective Services Committee
REGULAR AGENDA

RE: **Crater Creek Post-Wildfire Natural Hazard Risk Analysis**

Subject: Crater Creek Post-Wildfire Natural Hazard Risk Analysis - Preliminary Results

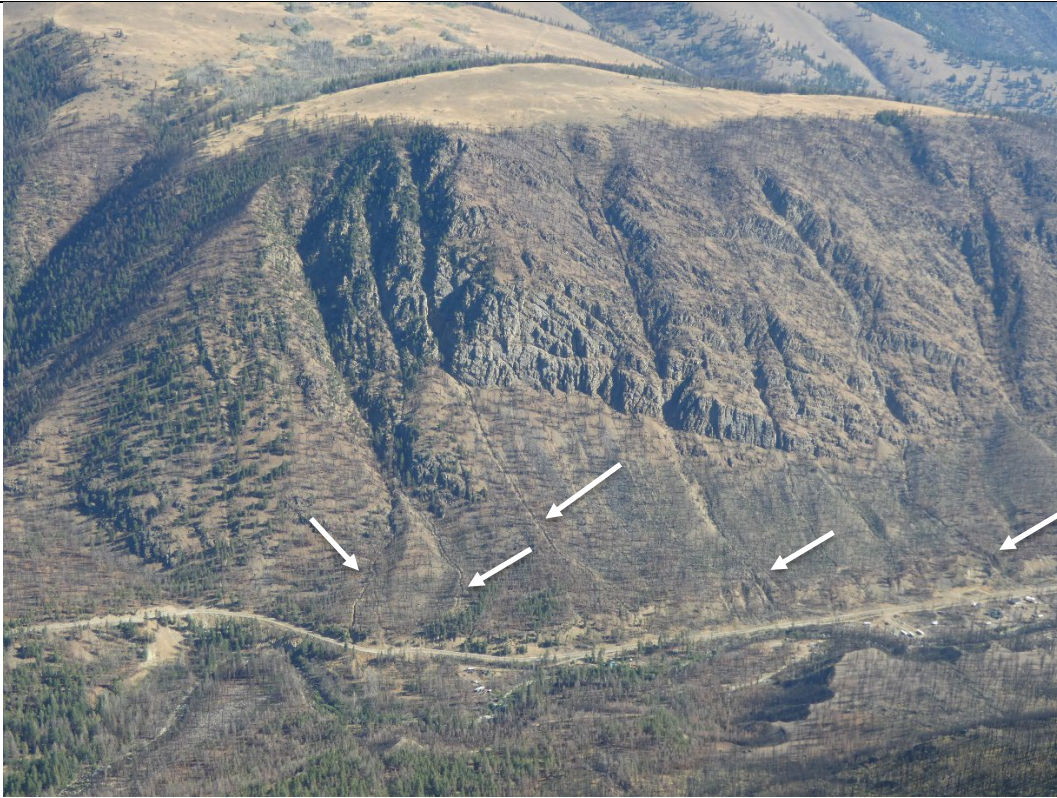
- slopes and gullies upslope of Ashnola Road, to approx. 16 km. Small-scale rockfall and sediment-laden flooding has already been reported along the Ashnola Road (Aug. 2024);

Photo 1: Small tributary gullies and face unit slopes on north side of Ashnola River. Post-wildfire surface erosion and sediment-laden flows are visible (arrows).

For the areas identified as having a high to very high partial risk for post-wildfire natural hazards, mitigation measures begin with increased awareness, monitoring, and emergency preparedness activities. In the short-term, downstream drainage structures in the identified areas should be inspected and maintained to ensure clear passage for sediment-laden water and debris. Other measures such as information bulletins and road signage will increase awareness among residents and the traveling public.

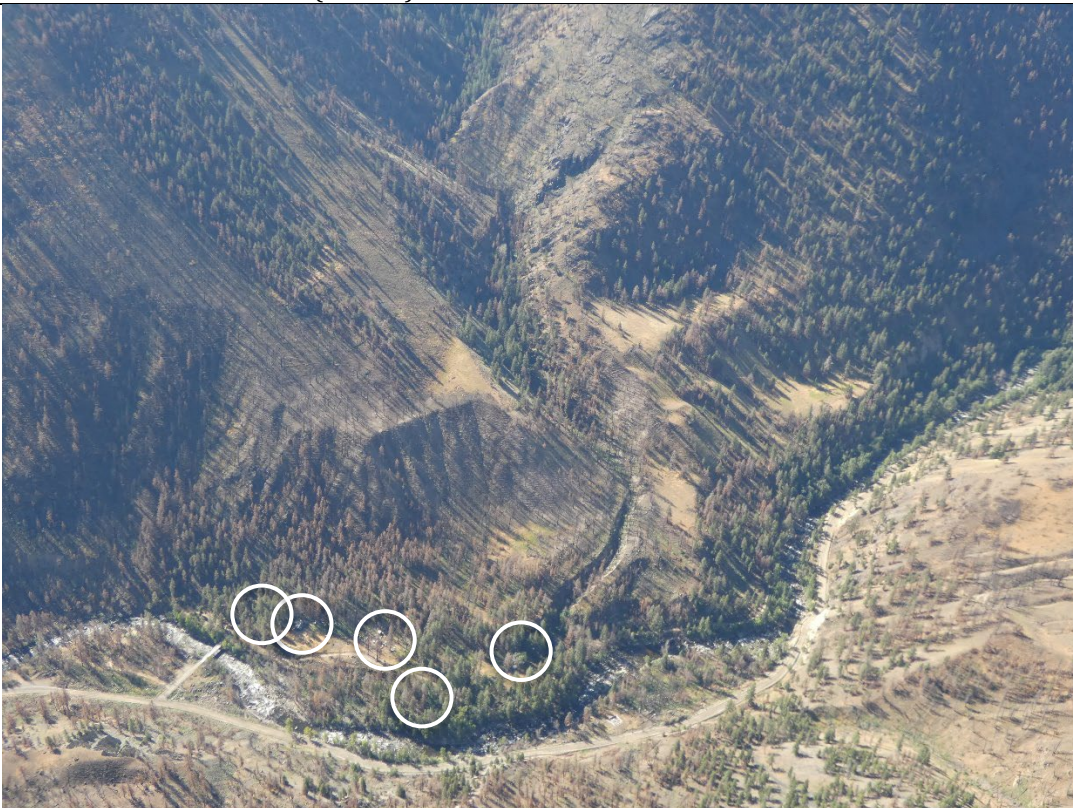
- catchment areas and fans within the Lower Ashnola River watershed, including Red Bridge Creek, Crater Creek, Webster Creek, Ewart Creek, and Lakeview Creek. Road washouts have already occurred within Red Bridge Creek (July 2024), and larger-scale sediment-laden peak flow events have already occurred on Ewart Creek, and on Skwekust Creek (July-Aug 2024); and,

Photo 2: View south to fan area of Webster Creek. Note bridge crossing Ashnola River from Ashnola Road to Ewart Road. Residences (approx.) along Ewart Road are circled.

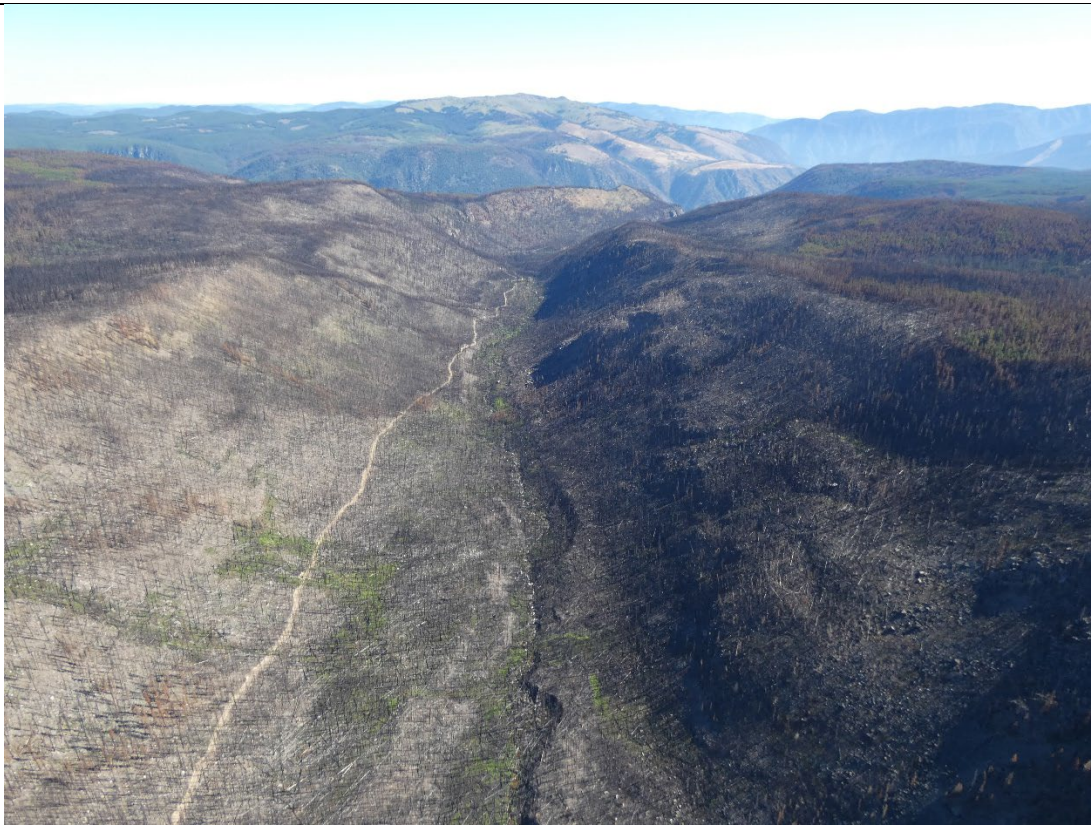
General Location	Elements at Risk	Post-Wildfire Natural Hazards ²
Creek, and Lakeview Creek (see Photo 3)	Ewart Creek and Ashnola River Trails and Provincial Park access within Lakeview Creek and Ewart Creek catchments	subsequently release, causing elevated peak flows on the Ashnola River.
Fan areas of catchments on the west side of the Lower Similkameen River valley, including Snehumption Creek (see Photo 4 & 5), Shoudy Creek (see Photo 6), Robert (aka Moonshine) Creek (see Photo 7), Susap Creek (see Photo 8), and Sintelhahten Creek (see Photo 9)	Private properties, and structures on IR Land Chopaka Road (North and South)	Elevated likelihood of high peak flows and debris flood events on Snehumption Creek and Susap Creek. Elevated likelihood for debris flows and sediment-laden flooding on smaller catchments such as Shoudy Creek, Robert Creek, Sintelhahten Creek, and other small catchments above Chopaka Road.

Photo 3: View north (downstream) along Lakeview Creek with access road to Cathedral Provincial Park visible on the left.

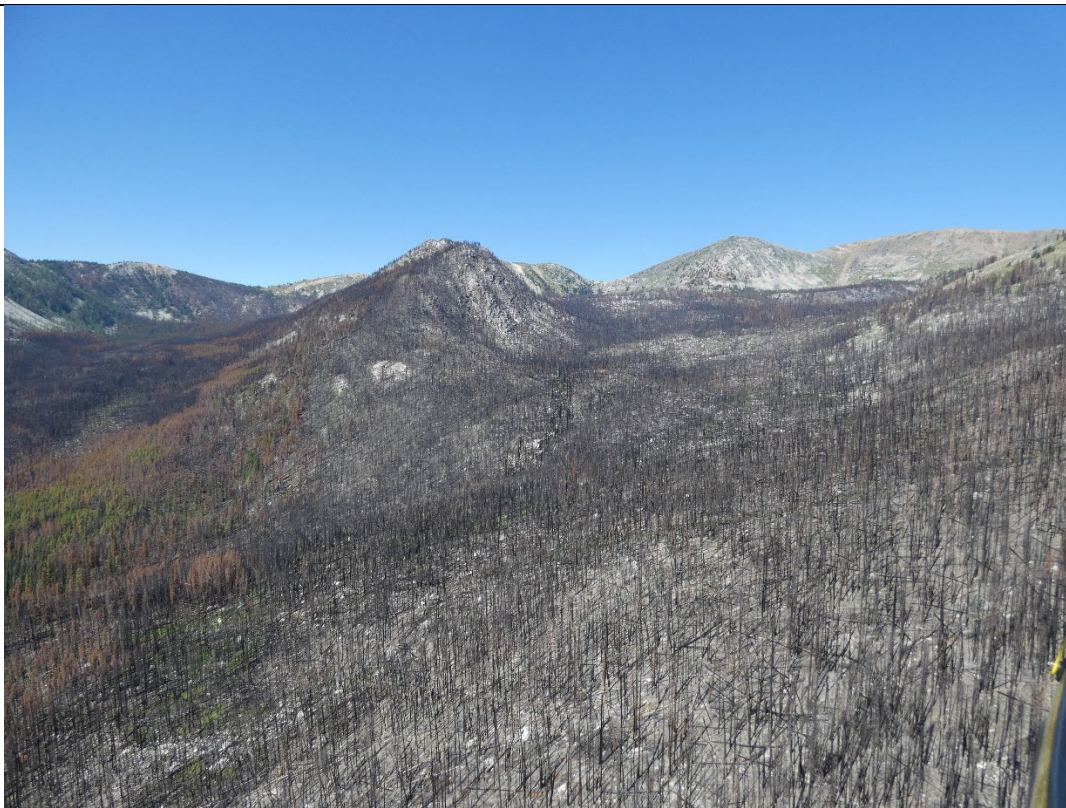
Photo 4: Burned headwater area within the Snehumption Creek watershed.

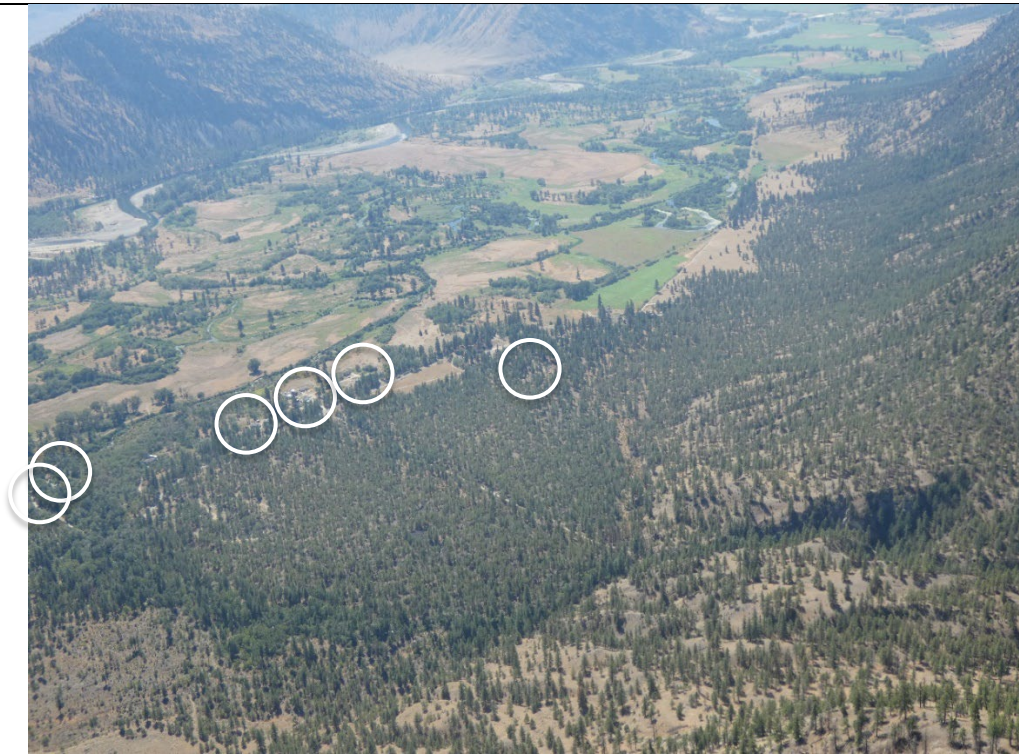
Photo 5: View south-east showing Snehumption Creek fan area. Note residences (circled) and access along Chopaka Road.

Strong consideration for the development of a weather-based early warning system is recommended for those properties situated on fans within the LSIB Community (including Chopaka 7 & 8 IR, Narcisse's Farm IR, and portions of Lower Similkameen 2 IR) and for parcels within RDOS Electoral Area B, situated on the west side of the Lower Similkameen River area. The rationale for a warning system is based on several damaging debris flow / debris flood events that have occurred since the 2018 Snowy Mountain Fire², and on the elevated potential likelihood for future damaging events. Considerations for a warning system should include the potential for false alarms. The candidate areas include properties on fan areas of Snehumption Creek, Shoudy Creek, Robert (aka Moonshine) Creek, Susap Creek, and Sintlehahten Creek.

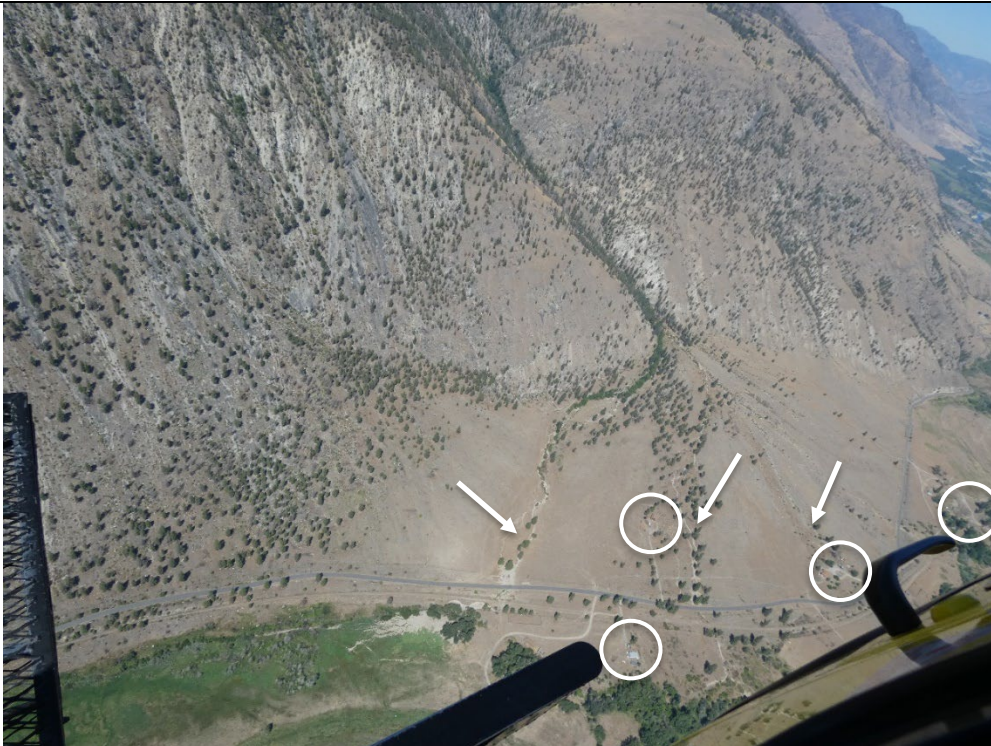
² Damaging flows have occurred on Sintlehahten Creek, Robert (aka Moonshine) Creek (May 2023), and Shoudy Creek (June 2023)

Photo 6: Shoudy Creek fan area showing multiple channels (arrows) that experienced recent sediment-laden flooding events resulting in impacts to Chopaka Road. Note residences (circled).

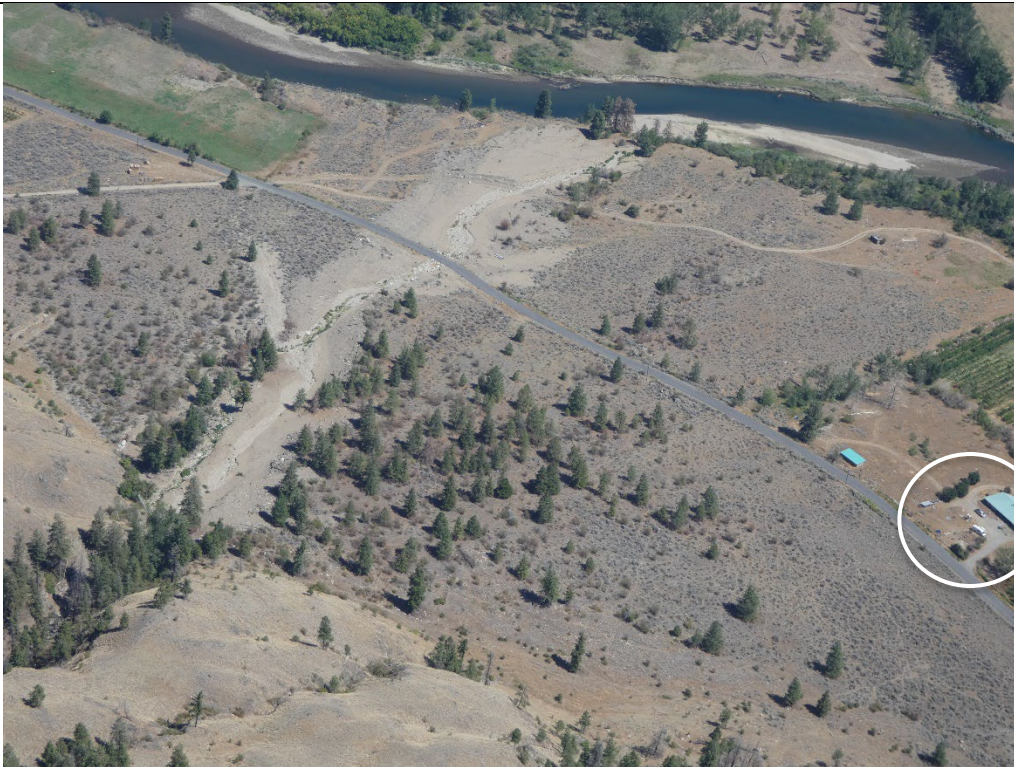
Photo 7: View north showing Robert (aka Moonshine) Creek fan area. Note evidence of May 2023 flood event, nearby residences (circled) and Chopaka Road. Similkameen River is in the background.

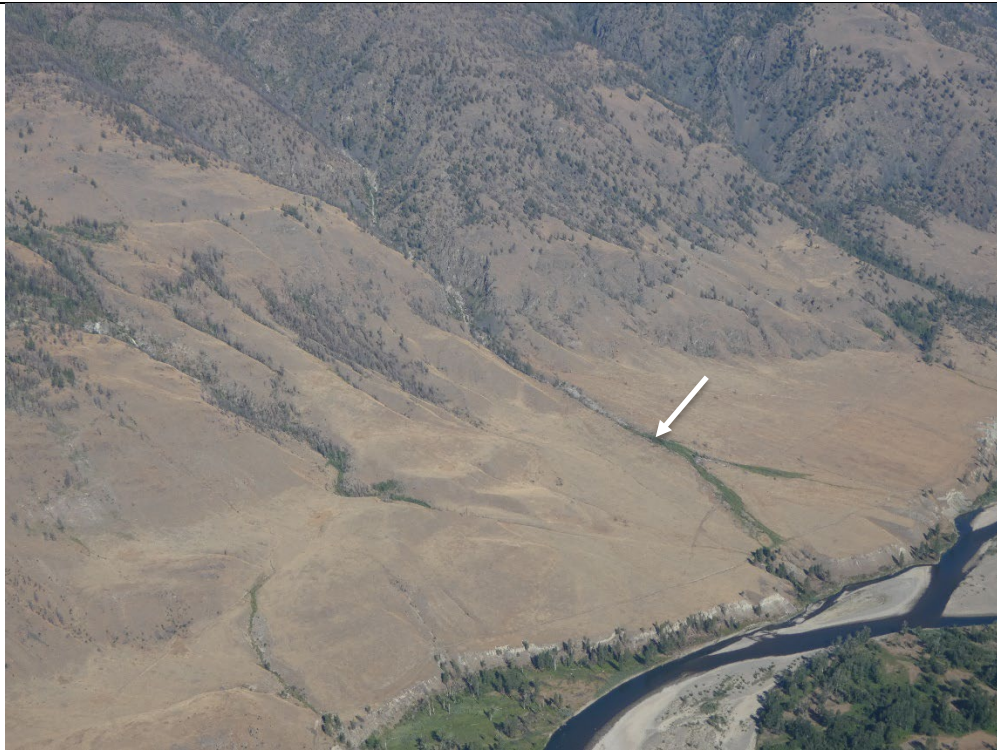
Photo 9: View north showing Sintelhahten Creek fan area (arrow) and other small tributaries. Note Chopaka Road north access road (faint, unpaved trail).
